PENNGUARD™ Block Lining System Applied to 5 Small Diameter Flues

Challenge: Replace small diameter flues in aggressive service with minimum downtime

Solution: Prefabricate new, modular flue with custom-designed PENNGUARD Block Lining System in a nearby laydown area then, over about 2 weeks, shut down and replace existing flues

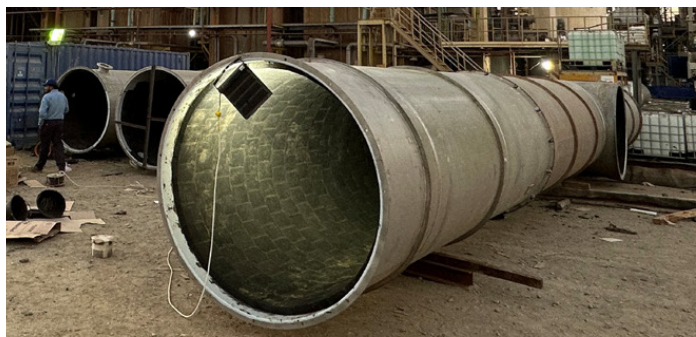
1. Project Laydown Area - PENNGUARD Block was applied to each section of a flue while laying horizontal on a ground level

Dominion lined each new flue in a nearby laydown area, mobilizing a total of 3 times, once for each flue, to complete the project. First, a new flue was fabricated, laid on the ground horizontally and lined. Next, Dominion removed an existing flue and replaced it with a new one.

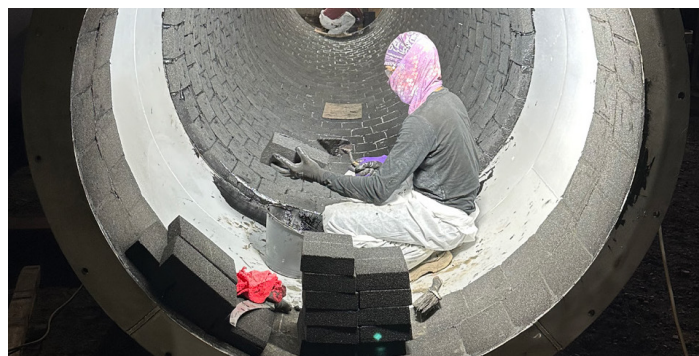
2. All day (24-Hour) Shifts - A flue being worked on at night using proper safety precautions

Only one off-line flue was being replaced at any given time, allowing the power plant to remain in operation throughout the project. Extra planning kept workers safe while standing up each new flue, right beside 2 hot flues. Working shifts 24 hours a day, 7 days a week, Dominion Arabia replaced each newly lined flue in just 15 calendar days.

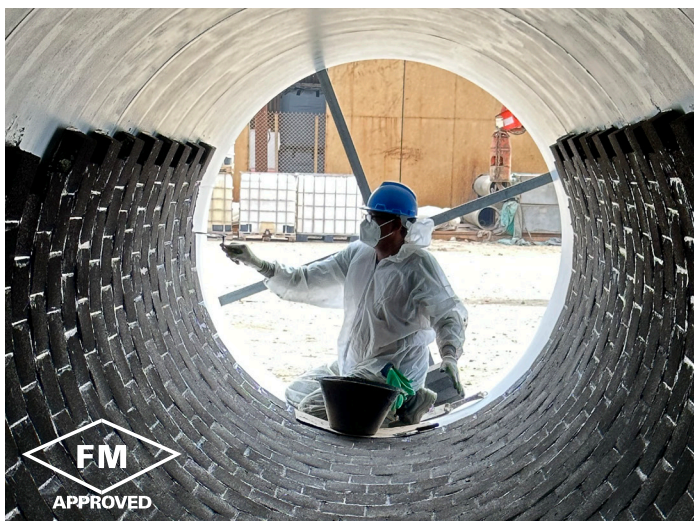
3. Small Diameter Flues - PENNGUARD Block Lining System being applied in a 1.7 m (5'7") diameter flue

Suitability for Confined Space Installation. With only 1.7 m diameter, the flues did not offer a lot of room for personnel access and lining installation. The PENNGUARD Block Lining System consists of a primer, blocks, and adhesive/membrane. The primer could be applied with a roller, and the adhesive/membrane could be applied with a flat trowel. The absence of spray-applied components favored successful installation in a confined space.

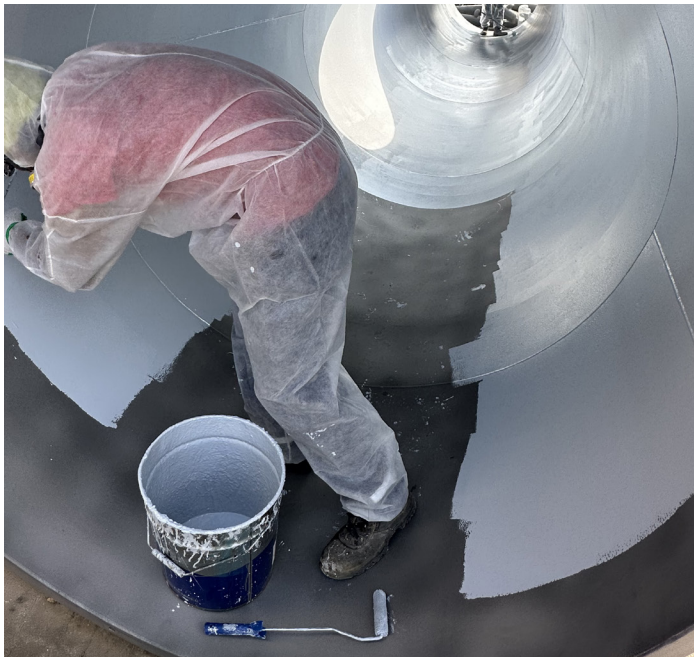
6. Primer Application - PENNGUARD™ HP Epoxy Primer being applied inside flue via paint roller

Dominion applied the PENNGUARD HP Epoxy Primer over the prepared substrate with a roller. Using a roller to apply the primer allowed the installer to control the film thickness, avoid wasting material, and protect the fresh coating from marring. Applying the primer with spray equipment inside the small, tubular cans would have introduced avoidable challenges to a quality installation.

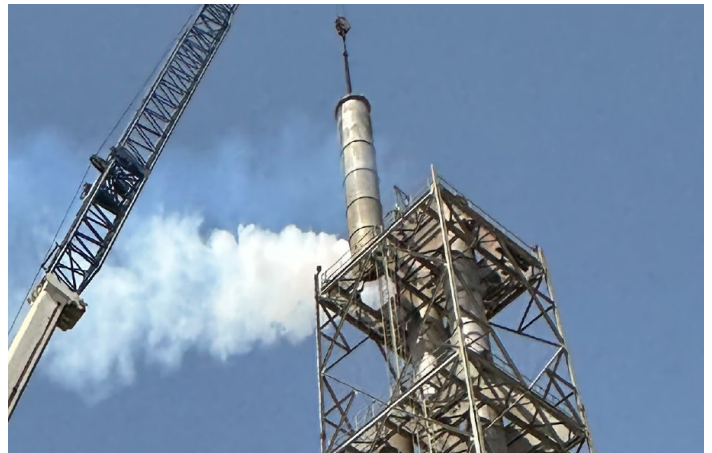
7. Flue Sections Craned Into Place - The gaps between the flues were then covered with PENNGUARD™ Adhesive Membrane and PENNGUARD™ Block prior to final inspection

To make the most efficient use of materials, installation labor and QA representation, multiple flues were staged in the laydown area and lined simultaneously. The PENNGUARD Block was laid up to a precise distance shy of the ends of each can. Once the cans were lifted into place and assembled, the PENNGUARD Block Lining System was applied over the recessed areas, bridging the seams between cans.

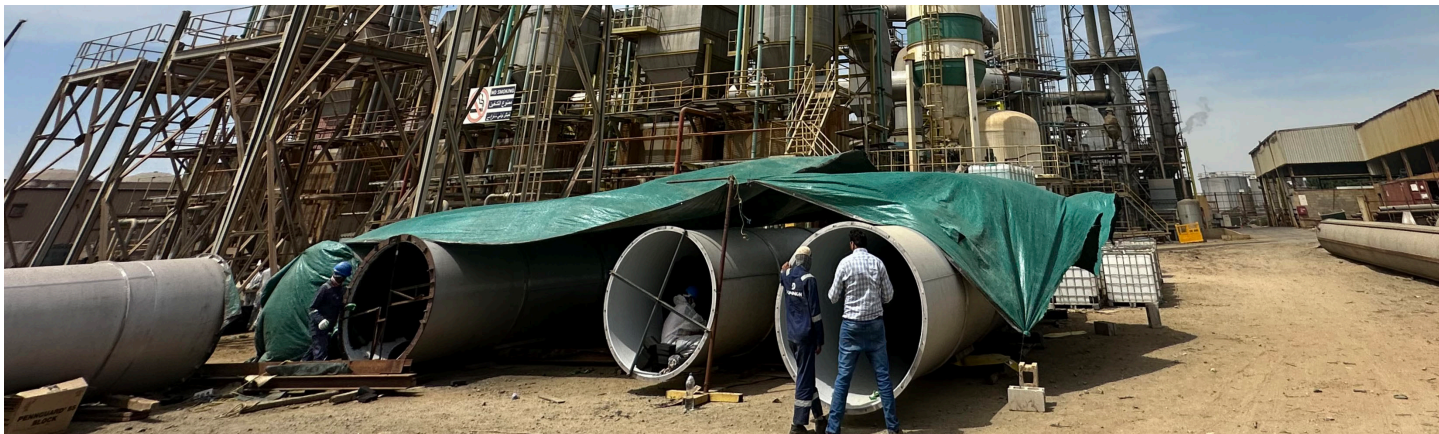
8. Job Site Perspective - The flue sections being coated in the laydown area were disassembled from the tower structure in the forefront
